Title: **Amberleigh HOA – Level 1 Limited Visual & Level 2 Basic Tree Risk Assessment**

Prepared for: **Amberleigh HOA**
Attn: Mark Beales, Amberleigh HOA Board President
1820 163rd Street SE
Mill Creek, WA 98012

Prepared by: Urban Forestry Services | Bartlett Consulting
Josh Hollinger, Consulting Arborist
ISA Certified Arborist® WE-12135AU
Tree Risk Assessment Qualified

Date: April 21, 2025

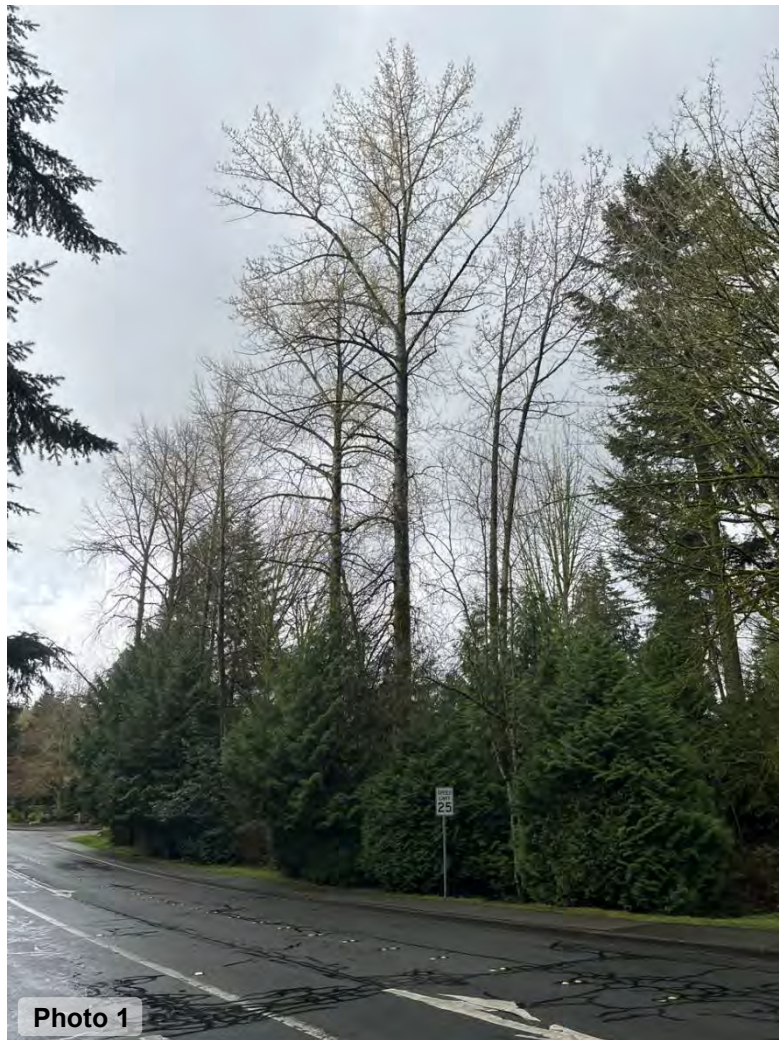
Photo 1

Photo 1. Tract G included several native tree species. The viewer is on Seattle Hill Road looking southwest.

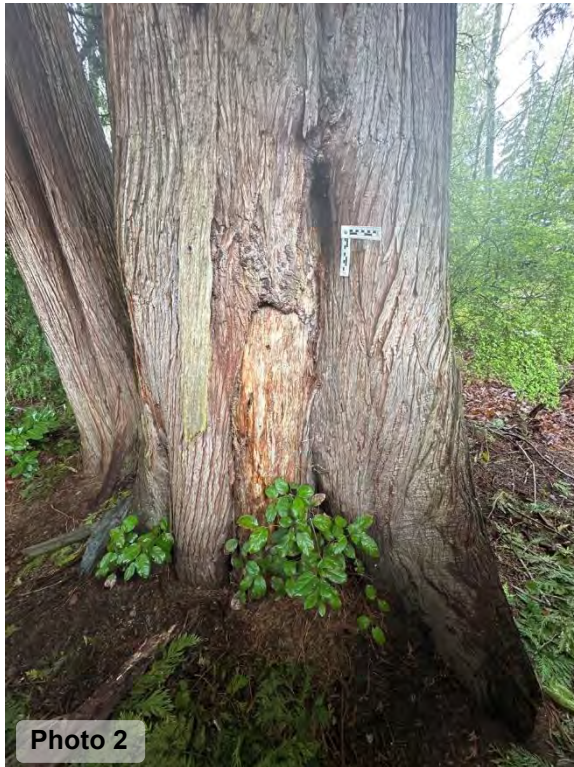
- Tree 136 – There is a large wound with visible signs of decay. I was unable to determine the extent of the decay using Level 2 assessment methods.
- Tree 143 – I observed brittle cinder fungus (*Kretzschmaria deusta*) growing at two (2) locations on the lower trunk. Brittle cinder fungus feeds on living wood which can lead to failure of the infected tree part. I was unable to determine the structural condition of the lower trunk using Level 2 assessment methods.

| Tree Condition | |
|---|--|
| 136 | There is a large wound on the south side of the trunk (Photo 2). |

Photos 2 to 5. Photo 1 shows the large wound on Tree 136. A crack has developed at the attachment point of a large stem on Tree 146 (Photo 2). Brittle cinder fungus is growing on Tree 143 (Photo 3). Ganoderma conks are growing at the base of Tree 149 (Photo 4). The white ruler in Photos 1, 3, and 4 is four (4) inches long.

Test 1 was performed at the large wound on the lower trunk. Wood density appears normal to a depth of four (4) inches, after that there is a complete drop in the density reading to the end of the test which indicates possible advanced decay or a cavity.

Test 2 was performed perpendicular to the wound on the lower trunk. Testing indicated decay at a depth of 3.5 to 7 inches and at a depth of 9 to 16 inches.

- Tree 136 - Monitor and reassess the overall risk rating of this tree in three (3) years using ISA Level 3 Advanced assessment methods.
- Tree 143 - Reduce the length of branches extending toward the target to reduce the likelihood of impact from branch failure and inspect the internal condition of the lower trunk using ISA Level 3 Advanced assessment methods in three (3) years.

I recommend that both trees be retained and inspected using ISA Level 3 Advanced Assessment methods in three (3) years from the date of this report.

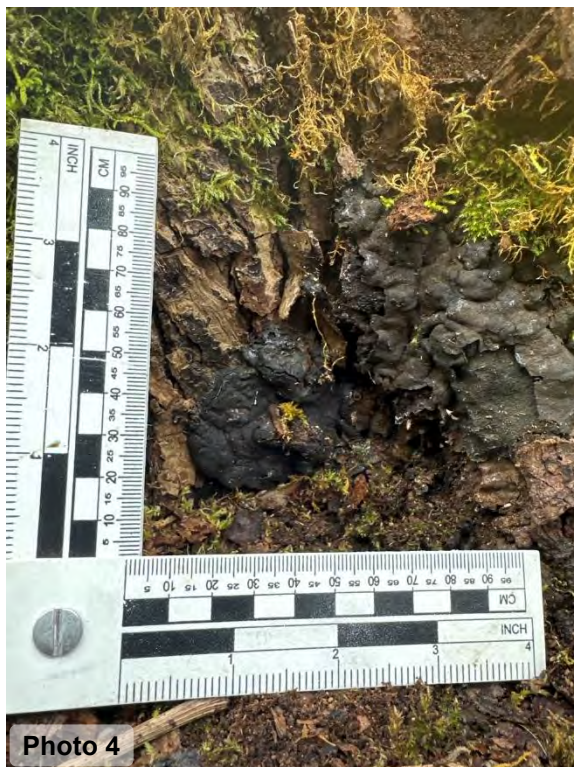
| Tree Condition | |
|---|--|
| 149 | Several <i>Ganoderma applanatum</i> conks are growing on the base of the trunk (Photo 4). |

To reduce the likelihood of impact for surrounding targets, I recommend removing Trees 142, 145, and 149.

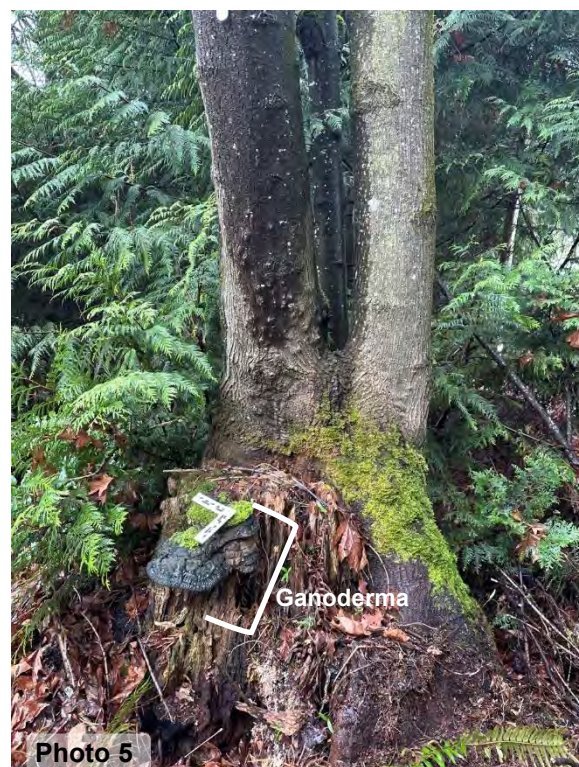
| Tree Condition | |
|---|--|
| 152 | Multiple leading stems that are narrowly attached (Photo 5). |

I recommend the following pruning treatments for Trees 143, 146, and 152 to reduce the likelihood of impact in the event of branch failure.
